NBSIR 74-474

Metallurgical Analysis of Wear Particles and Wearing Surfaces

April 1974

Final Report
NAONR-31-73
NR 229-014

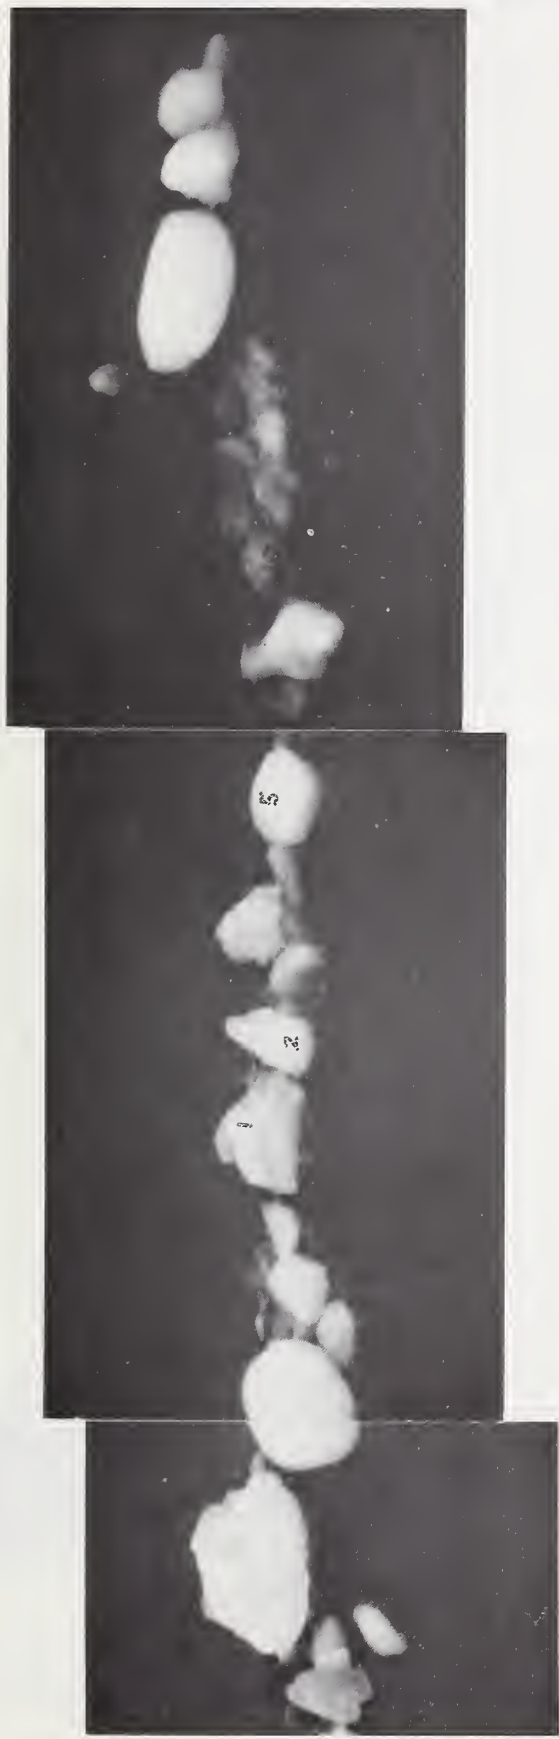
Fig. 18. String S₂ in SEM. Note contrast difference among particles. M = 11,000x.

Another string (S_2) is shown in Fig. 18. Again considerable size and shape variation among the particles is seen. Fine structural details can be observed here in emissive mode imaging. The brightness differences between particles are seen again in this string. A portion of this string is shown in the TEM micrograph composite of Fig. 19. The labeled particles have been studied in diffraction. Particles 1, 3a, 3b, 9b, and 12 give principally iron oxide patterns. Particles 2, 4, 5, 7, 10, 13, 14, and 15 give strong α -Fe patterns. The remaining particles studied showed both iron and iron oxide content to a substantial amount. Some of the thinner particles (10, 13, 14, 15) appear to be solid, partially-oxidized iron fragments. Other particles (3a, 9a) appear to be more a collection of small fragments, principally iron oxide.

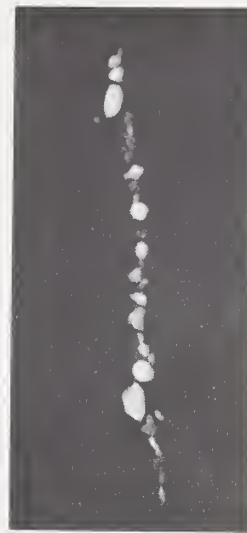
F-1851. String S₂ observed in SEM. M = 2,200x.

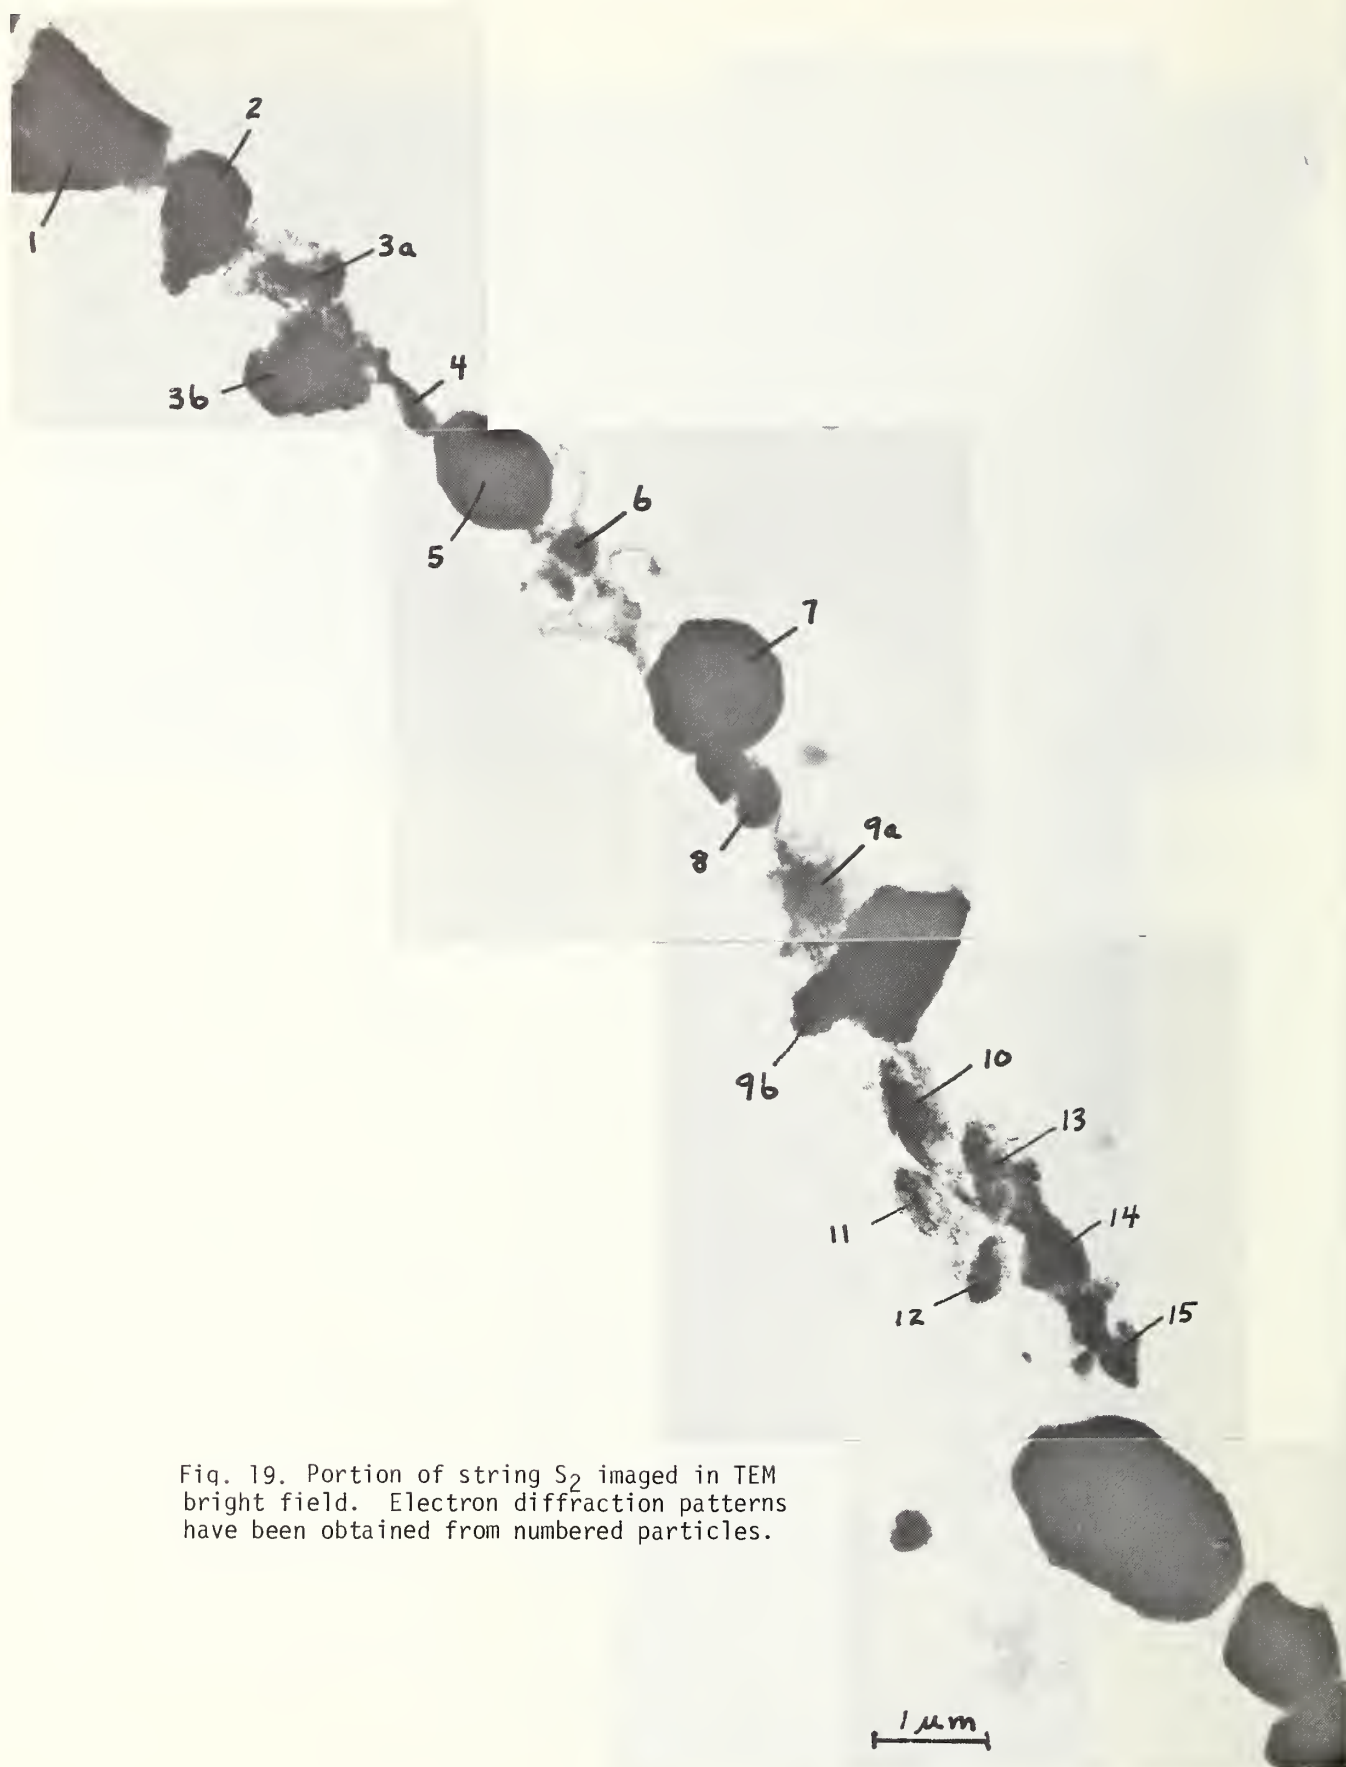
Fig. 19. Portion of string S₂ imaged in TEM bright field. Electron diffraction patterns have been obtained from numbered particles.

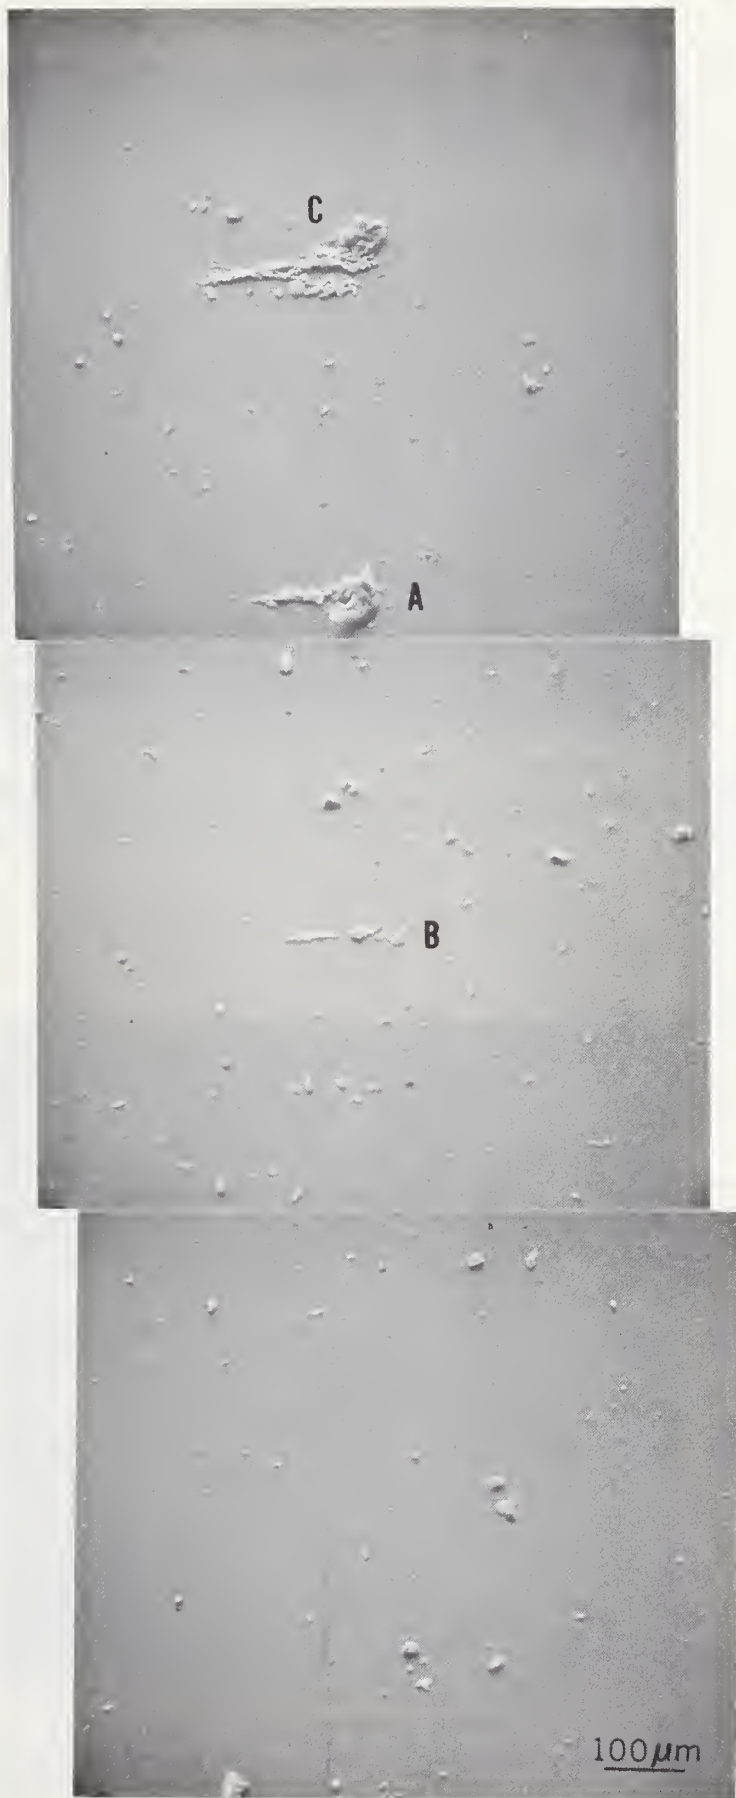
Fig. 20. Ferrogram 2119 from single ball test run. Initial particle deposit is at C. Flow is downward. M = 100x.

A series of oil samples from a test of an M50 steel (includes 4% Cr, 4% V) ball and race was obtained by Trans-Sonics and processed to produce several Ferrograms. A silicon-bronze ball retainer was included in the mechanical testing device. The oil was MIL-L-23699 type held at a temperature of 300°F. The test involved a time-to-failure of 9h 55m and a ball Hertz stress of 600 kpsi maximum. At failure the ball became driven into the retainer. The Ferrogram (F-2119) was prepared using carbon precoated slides from an oil sample taken at 8h time (1h 55m prior to failure).

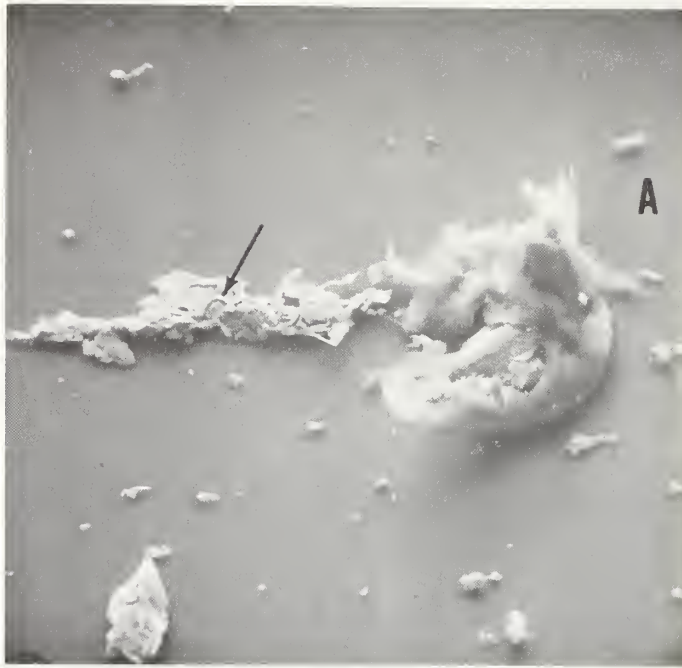
Fig.21(a); Region A from above shows string containing flake-like particles and several examples of ribbon-like particles. M = 500X.

Region A in Fig. 20 is shown again in Fig. 21. Several examples of long ribbon-like particles are found in that string together with some flake-like particles. Both types have surface structures and markings that suggest plastic deformation and slip bands. X-ray analysis results are given. Figure 21 shows the region B in more detail. One

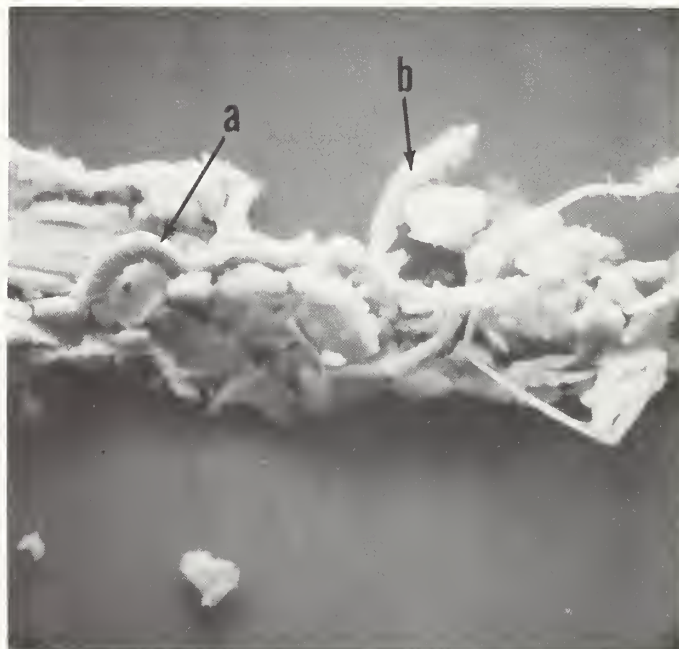
(b). Details of ribbon-like particles in above string. Note apparent deformation markings on ribbon (a). Both ribbons indicated are alloy steel with principal elements Fe(9,300 cts), Cr(3,200 cts) and Ni(1,000 cts). Ribbon (b) also contains Cu. M = 2,000X.

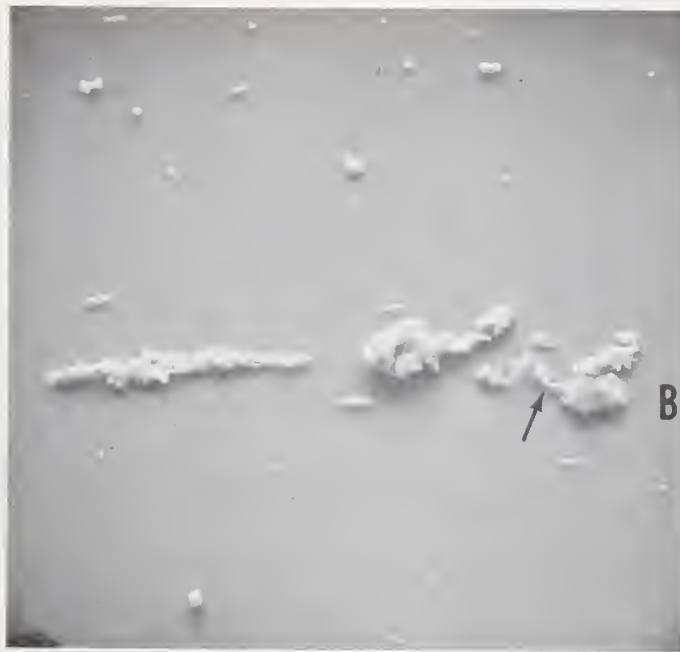
Fig.22(a). Region B from above. Several small particle strings are present. M = 500X.

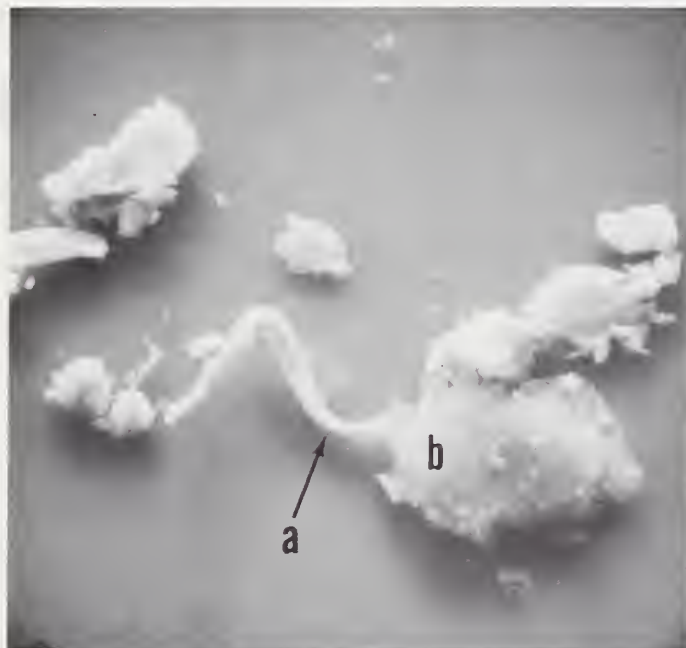
(b). Details of ribbon-like particle in above string (a), containing Fe, Cr, and Ni. Blob (b) contains only Fe, about 40% that of (a) plus oil residue and is probably iron oxide. M = 2,000X.

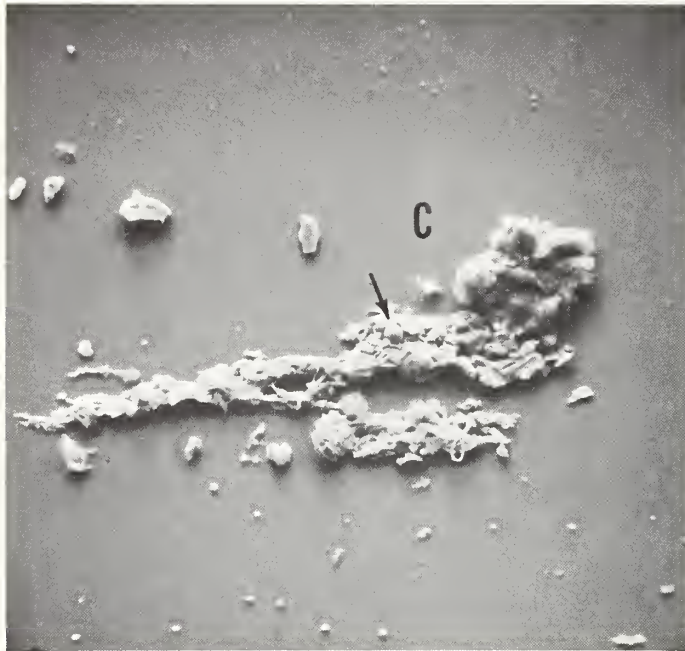
Fig. 23(a). Particle strings in Region C of above. Flake and ribbon-like particles and one spheroid (arrow) are seen. $M = 300X$.

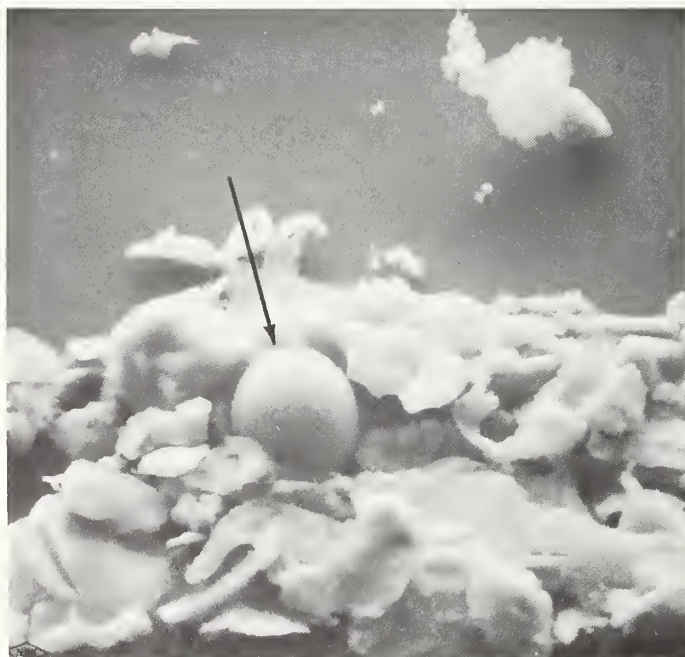
(b). Details of above string and spheroidal particle of $8\text{ }\mu\text{m}$ diameter. $M = 2,000X$.

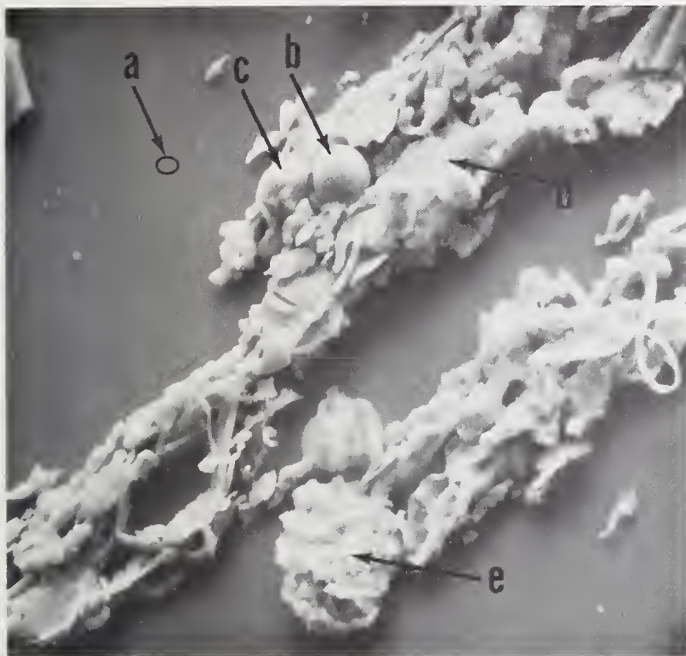
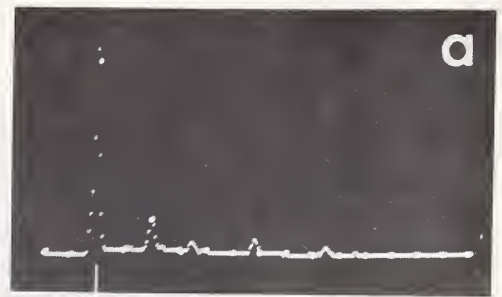
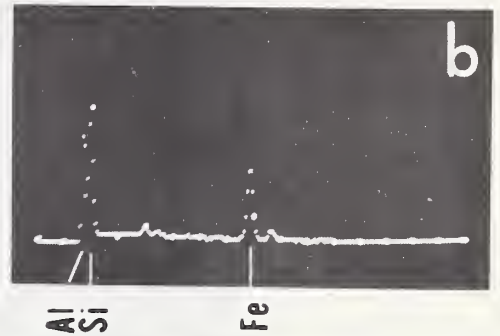
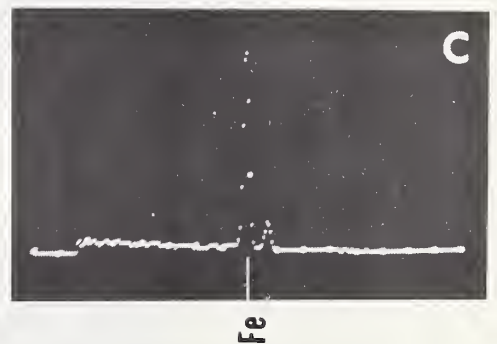
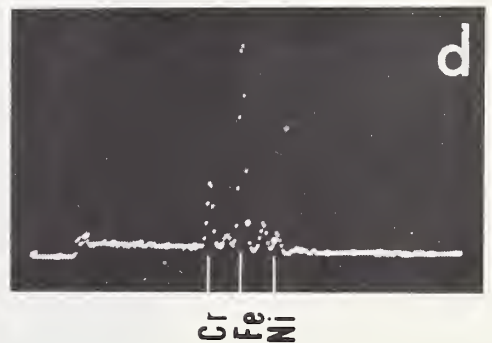
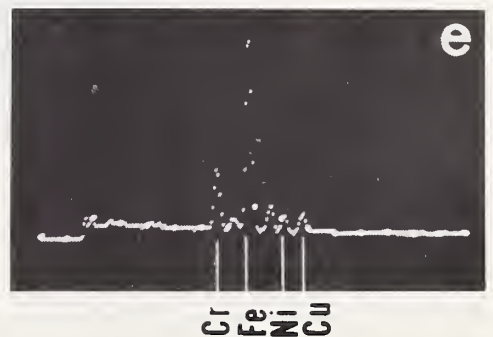
Fig. 24. Area of above with X-ray emission analyses shown for labeled particles and background (a). Spheroidal particle (b) has considerable Si, Al, and Fe content. Particle (c) is principally iron while particle (d) has substantial Cr and Ni content indicating alloy steel particle. Particle (e) contains Cu in addition. $M = 1,000\times$.

In summary, only one spheroid has been found among the particles from this single ball test. It is relatively large and it contains significant amounts of silicon and aluminum. There is no appearance of a rough or cracked oxide covering on the sphere. Adjacent particles in the string that show a greater roughness do not show any significant silicon content. The ribbon-like particles found in this Ferrogram are typical cutting-wear particles.

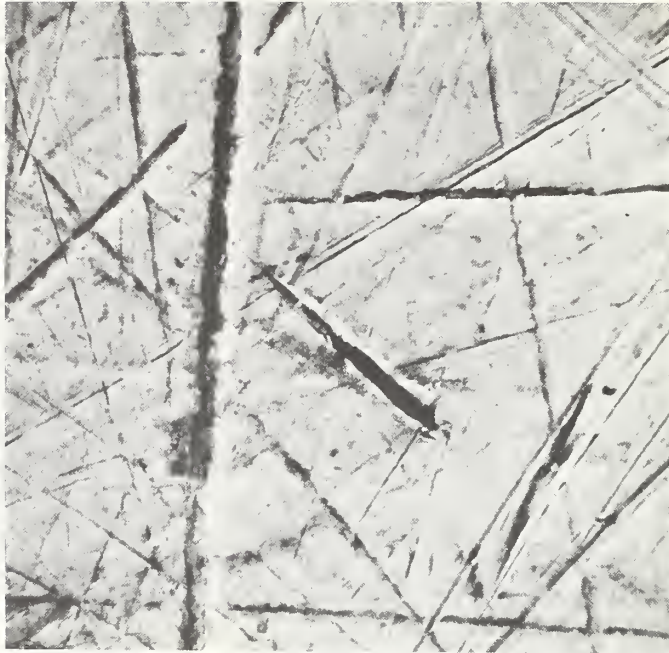
Fig. 25(a). Surface of bearing ball, 11/16 inch diameter, 52100 steel, after bearing bench test. Wear and gouge tracks are seen in SEM photo. $M = 3,000\times$.

A disassembled bearing that had failed during a bench test at SKF was examined to attempt to relate the particle debris obtained by the Ferrograph from the lubricating oil with the bearing surface structures and markings. An example is shown in Fig. 25 taken from one 52100 steel bearing ball. Some of the surface tracks seen in Fig. 25a may remain from initial finishing operations, however, many examples of deep wear gouges are present. Detailed examination indicated that plastically deformed metal at the gouge rim can be detached in the form of small particles (Fig. 25b). Larger particles may also form in this way as indicated by the 3 μ m particle formed in Fig. 26. Note the surface markings on the particle and the similarity with the bulk surface markings. This particular gouge appears to be

abrasively formed and the particle is formed from the edge displaced metal. The degree of plasticity of the surface material is apparent. Endo and Kotani¹⁴ have recently reported similar topographic observations on steel surfaces wearing under lubricated sliding conditions.

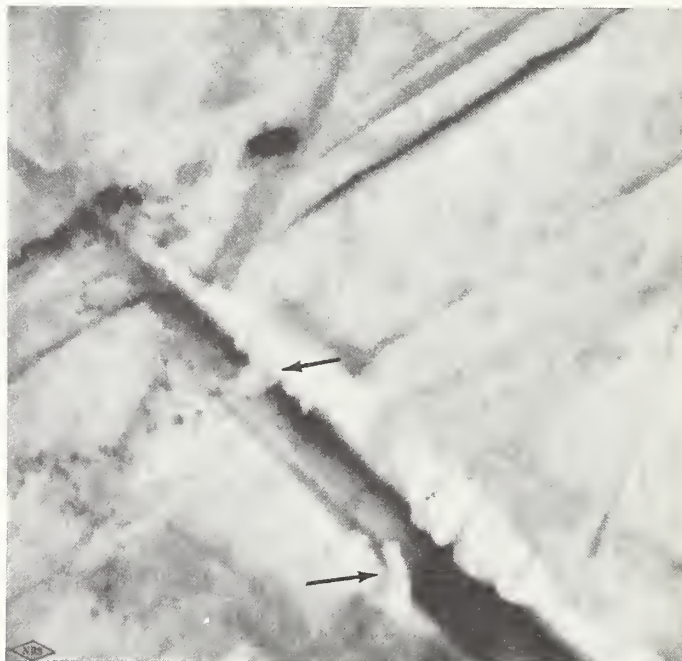
(b). Details of metal deformed over gouge rim. Several particles appear to be forming. $M = 12,000\times$.

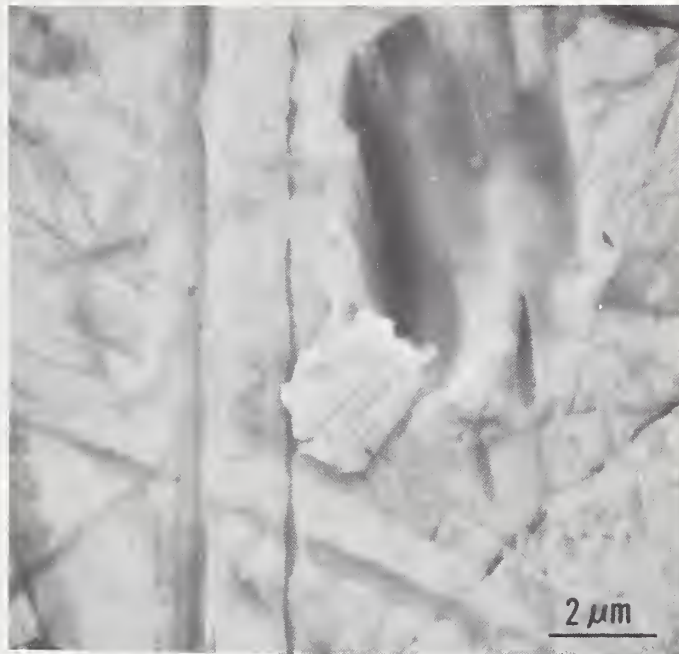
Fig. 26. Particle formed at edge of gouge on ball surface. Note surface wear markings on particle. $M = 7,000\times$.

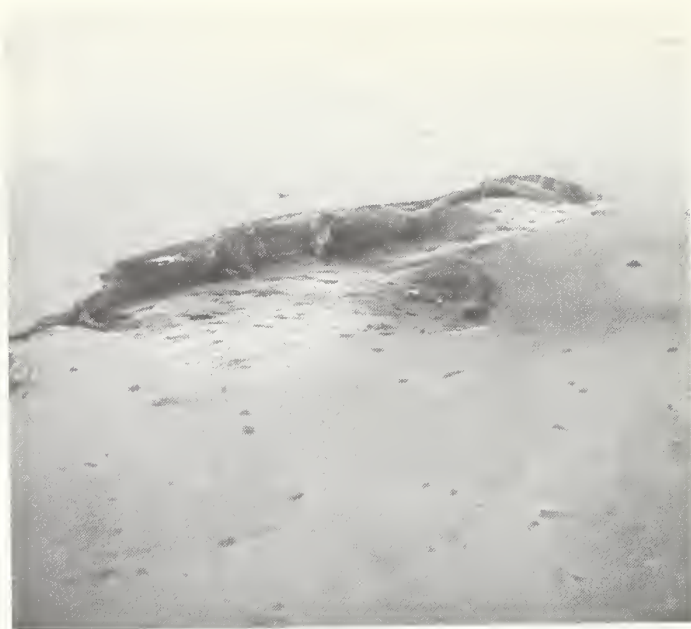
Fig. 27(a). Surface spall on ball from failed bearing.
M = 60x.

This ball was obtained from a failed bearing supplied by the Naval Ships Engineering Center and previously studied at Trans-Sonics. A spall occurred on the ball surface whose appearance (Fig. 27a) is typical of that type of damage. Considerable subsurface cracking is seen in this example extending away from the exposed fracture surface. The fracture surface morphology suggests that some plastic behavior occurred, perhaps after the spall fragment was produced. Many leaf-like protrusions remain on the surface, perhaps as a source of additional wear particles during subsequent contacts and motion. Several spheroidal particles were located on this surface, and a stereo-pair of SEM photographs of them is shown in Fig. 28. These spheres are not solid, metallic particles, however, since the X-ray emission peak intensity is considerably less than that obtained from the background and from other particles on the surface. They appear to be composed of iron and organic constituents.

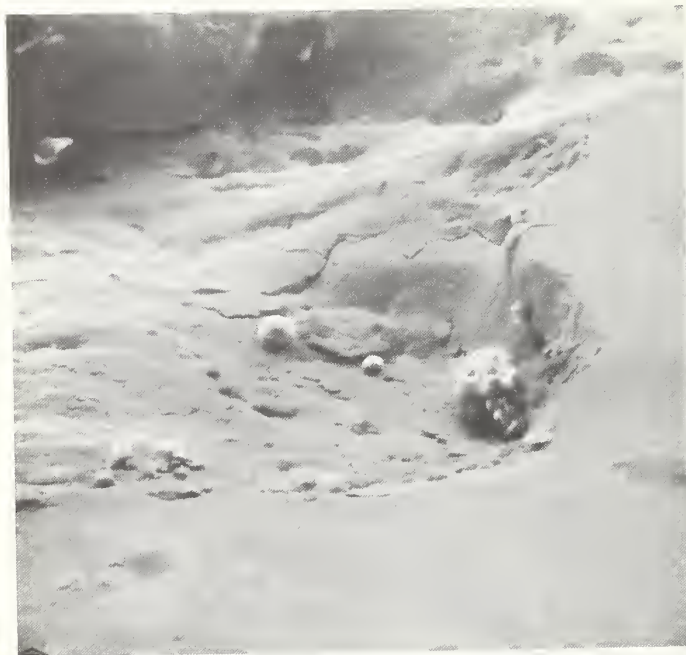
(b). Edge of above spall showing fracture surface features and spheroidal particles on surface. M = 240x.

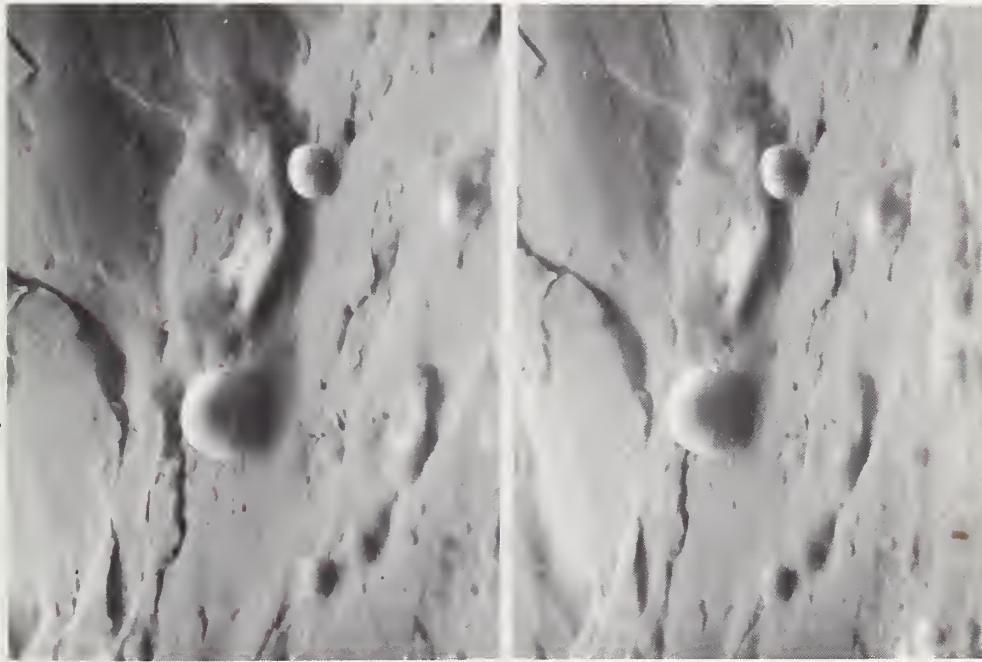
Fig. 28. SEM stereo photographs of above spheroidal particles on spall surface. Upper and lower views form right-left stereo pair, respectively. $M = 600\times$.
